HERITAGE REPAIRS REPORT

Project: Letheringham Lodge, Nr Wickham Market, Suffolk, IP13 0NA
Clients: Mr M & Mrs P Bickerton

LEATHERINGHAM LODGE – HERITAGE REPAIR REPORT

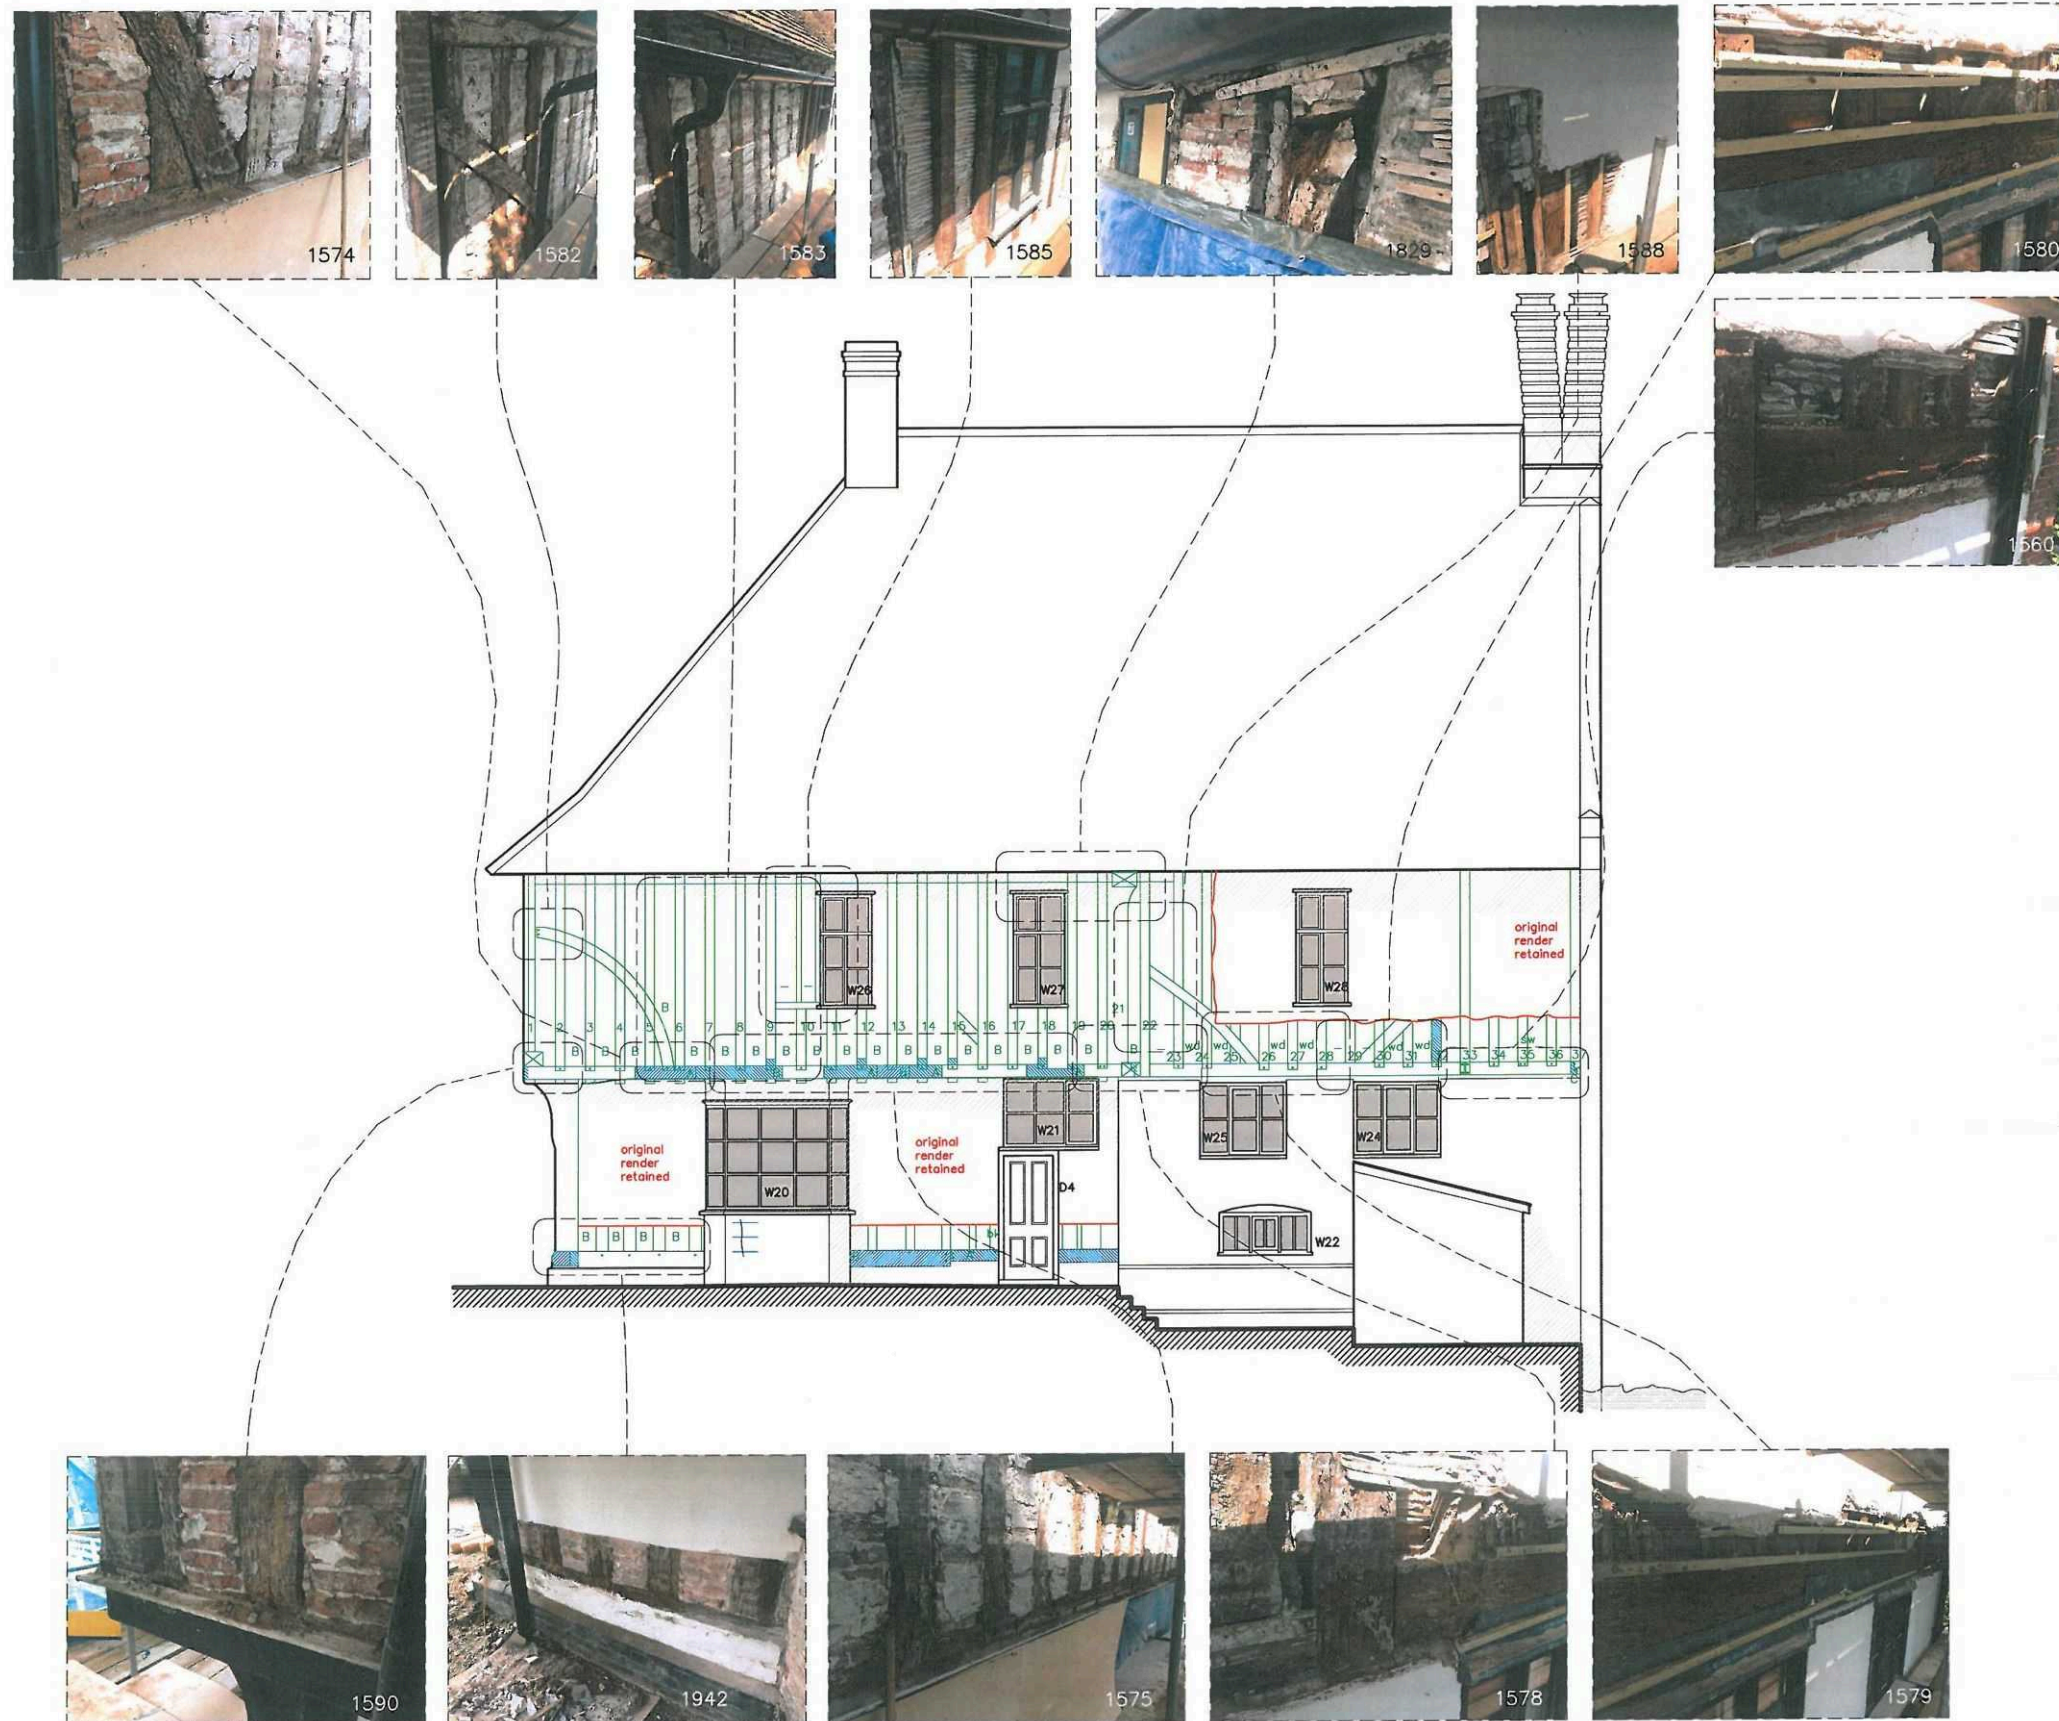
8. No significant defects found or repairs undertaken to north elevation of staircase enclosure.
9. Upper haunch to post found to be seriously affected by timber decay (death watch beetle and wet rot), such that discontinuous junction and load path between roof and jetty post. Complex repair undertaken using three sections of oak to rebuild top of post and end of dragon beam.

Repairs proposed:

1. Build up top of haunched post, Resin bonding and screwing the top of solid wood to post.

2. Cut to size second oak splice glueing and screws to top of brace, and additionally into end grain of brace, to form a solid joint.

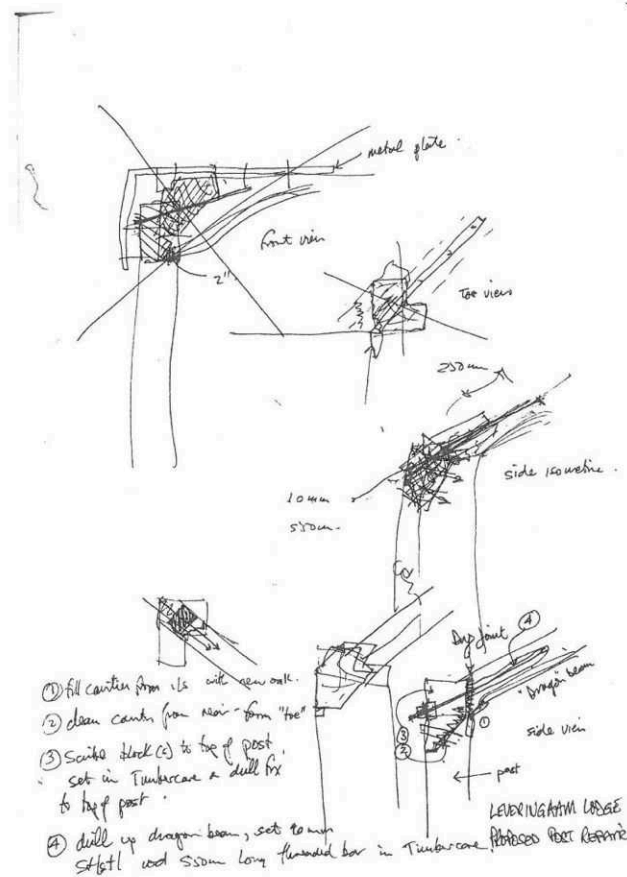
site note

Decayed end of hound
with loss at top —

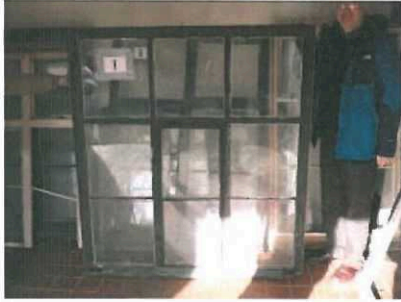
2.1	<p>WINDOW 1: Nine paned timber framed window with two mullions, mid level transom, three fixed fanlights, one metal lower level opening metal casement, single glazed, size 59" x 64".</p>

<p>REPAIRS: Carefully strip the paint from the window frame and remove the glass where necessary in order to facilitate the repairs.</p> <p>Carry out two squinted half lap splice repairs to jambs forming a new tenon and replace the cill in oak to match that of the existing. Replace one broken pane of glass, re-face putty.</p> <p>Overhaul the opening casements and window furniture to ensure they are operating as intended and prepare ready for redecoration.</p>	ITEM

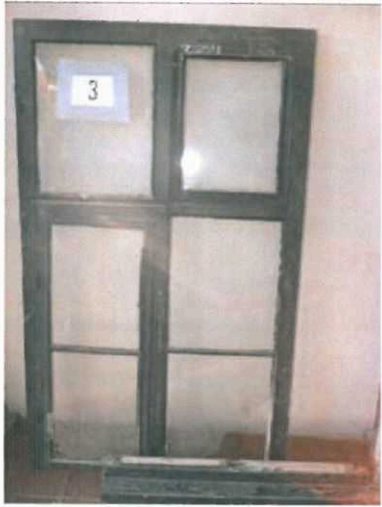
2.3	<p>WINDOW 3: Six paned timber framed window with central mullion, mid level transom, sub cill, with metal opening fanlight and low level casement, single glazed, size 37.5" x 67"</p>

<p>REPAIRS: Carefully strip the paint from the window frame and remove the low level glass where necessary in order to facilitate the repairs. Reinstall the existing cill by carrying out three squinted half lap splice repairs to the two jambs and central mullion. Replace the broken glass and reinstate that previously removed, face putty and prepare for re-decoration. Overhaul the opening casement and window furniture to ensure they are operating as intended and prepare ready for redecoration.</p>	ITEM

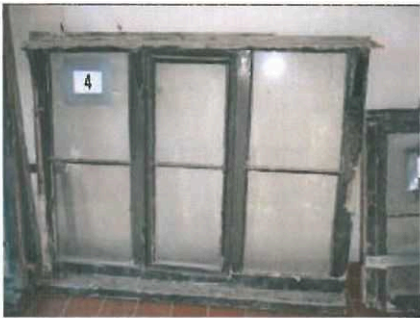
2.4	<p>WINDOW 4: Six paned timber framed window with two mullions, metal centrally opening casement, timber pretence board supported off four timber brackets, single glazed, size 54" x 44".</p>

<p>REPAIRS: Carefully strip the paint from the window frame and remove the glass where necessary in order to facilitate the repairs. Carry out a squinted half lap splice repair to the left hand jamb. Overhaul the opening casement and window furniture to ensure they are operating as intended and prepare ready for redecoration.</p>	ITEM

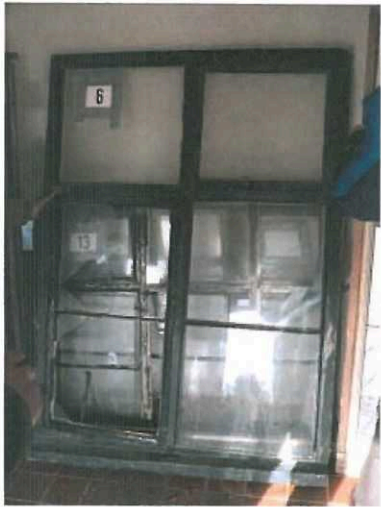
2.5	<p>WINDOW 6: Six paned timber framed window with central mullion, high level transom, one fixed fanlight, one metal opening fanlight, one low level fixed light, lower metal opening casements, single glazed, size 49" x 68".</p>

<p>REPAIRS: Carefully strip the paint from the window frame and remove the glass where necessary in order to facilitate the repairs.</p> <p>Carry out three squinted half lap splice repairs to jambs and mullion forming a new tenon and replace the cill in oak 5" x 3" to match that of the existing. Replace the missing two panes of glass, re-face putty.</p> <p>Overhaul the opening casements and window furniture to ensure they are operating as intended and prepare ready for redecoration.</p>	ITEM

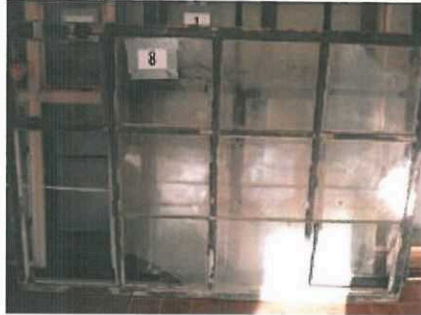
2.6	<p>WINDOW 8: Twelve paned timber framed window with two mullions, mid level transom, three fixed fanlights, one metal casement fanlight, single glazed, size 79" x 54"</p>

<p>REPAIRS: Carefully strip the paint from the window frame and remove the glass where necessary in order to facilitate the repairs.</p> <p>Carry out a squinted half lap splice repair to the left hand jamb forming a new tenon and replace the bottom rail and install a new sub cill in oak to match that of the existing. Replace the head of the window to match that of the existing. Replace five broken panes of glass installing two new metal cames and re-face putty.</p> <p>Overhaul the opening casement and window furniture to ensure they are operating as intended and prepare ready for redecoration.</p>	ITEM

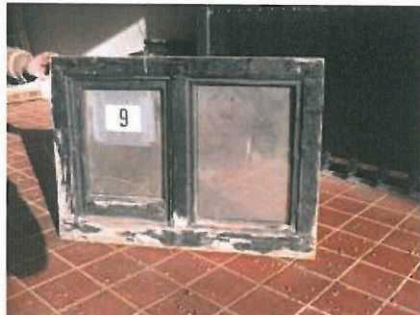
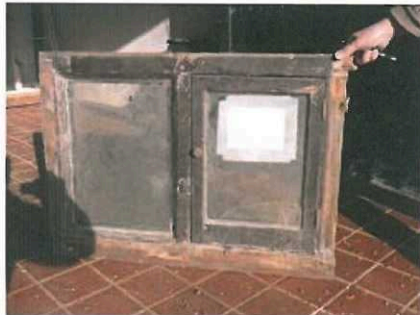
2.7	<p>WINDOW 9: Two paned timber framed window with central mullion, one fixed casement, one opening casement, single glazed, size 34" x 24"</p>

<p>REPAIRS: Carefully strip the paint from the window frame and remove the glass where necessary in order to facilitate the repairs.</p> <p>Carry out a squinted half lap splice repair to the left hand jamb forming a new tenon and replace fifty percent of the glazing beads.</p> <p>Replace the broken pane of glass and re-face putty.</p> <p>Overhaul the opening casement and window furniture to ensure they are operating as intended and prepare ready for redecoration.</p>	ITEM

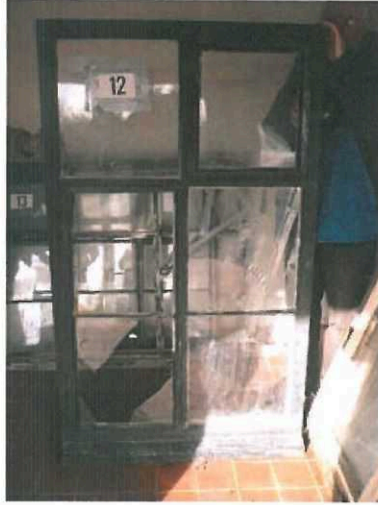
2.9	<p>WINDOW 12: Six paned timber framed window with central mullion, high level transom one fixed fanlight, one metal opening fanlight, one low level fixed light, lower metal opening casements, single glazed, size 40" x 67".</p>

<p>REPAIRS: Carefully strip the paint from the window frame and remove the glass, where necessary in order to facilitate the repairs. Allow to replace the three defective panes of glass and repair / replace the defective metal casement window.</p> <p>Overhaul the opening casements and window furniture to ensure they are operating as intended and prepare ready for redecoration.</p>	ITEM

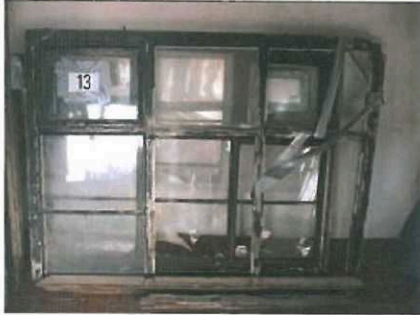
2.10	<p>WINDOW 13: Nine paned timber framed window with two mullions, high level transom, two fixed central fanlights, one metal opening fanlight, single glazed, size 60" x 44".</p>

<p>REPAIRS: Carefully strip the paint from the window frame and remove the glass, where necessary in order to facilitate the repairs. Replace the bottom rail and sub cill in oak.</p> <p>Carry out two squinted half lap splice repair to the jambs forming a new tenon and replace the cill in oak to match that of the existing. Replace two defectives metal comes and replace the four missing panes of glass and re-face putty.</p> <p>Overhaul the opening casement and window furniture to ensure they are operating as intended and prepare ready for redecoration.</p>	ITEM

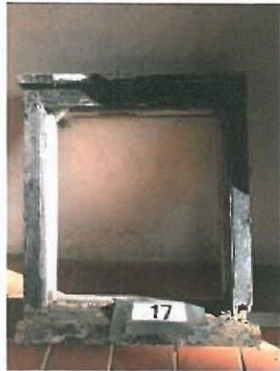
2.11	<p>WINDOW 17A: Single paned timber window, casement and glass missing.</p>

<p>REPAIRS: Carefully strip the paint from the window frame and remove the glass where necessary in order to facilitate the repairs.</p> <p>Carry out a squinted half lap splice repair to the right hand jamb 5" x 2.5" forming a new tenon and replace the cill in oak to match that of the existing. Replace missing casement 18" x 24" and re-glaze and face putty supplying and installing new window furniture to suit, prepare ready for redecoration.</p>	ITEM

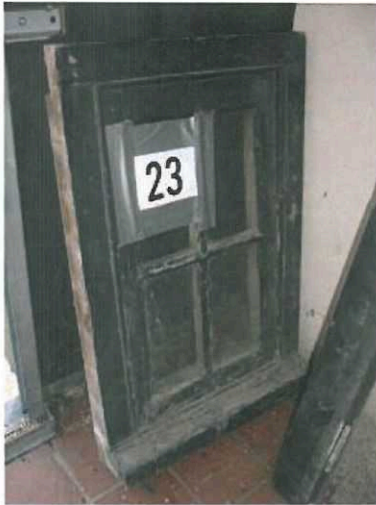
2.13	<p>WINDOW 23: Timber framed window with centre pivot casement with one horizontal and vertical glazing bar, single glazed, size 19" x 28.5".</p>

<p>REPAIRS: Carefully strip the paint off the window frame and renew casement window to match that of the existing, allowing to re-use the glass. Overhaul the window furniture re-install the glass and re-face putty and prepare ready for redecoration.</p>	ITEM

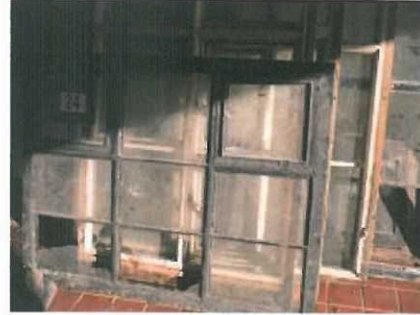
2.14	<p>WINDOW 24: Nine paned timber framed window with two mullions, transom, one fixed central fan light, two metal opening fanlights, single glazed, size 54" x 42"</p>

<p>REPAIRS: Carefully strip the paint from the window frame and remove the glass, where necessary in order to facilitate the repairs. Carry out a squinted half lap splice repair to the left hand jamb, forming a new tenon and replace the cill in oak to match that of the existing. Replace two broken panes of glass and re-face putty.</p> <p>Overhaul the opening casement and window furniture to ensure they are operating as intended and prepare ready for redecoration.</p>	ITEM	
------	---	------	--

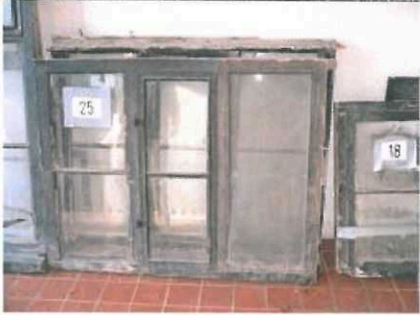
2.15	<p>WINDOW 25: Four paned timber framed window with two mullions, metal centrally opening metal casement, meshed two pane vented panel without glass, single glazed, size 53" x 41.5".</p>

<p>REPAIRS: Carefully strip the paint from the window frame and remove the glass where necessary in order to facilitate the repairs. Remove the defective bottom rail and replace the missing sub cill in oak. Carry out a two squinted half lap splice repair to the mullions. Overhaul the opening casement and window furniture to ensure they are operating as intended and prepare ready for redecoration.</p>	ITEM

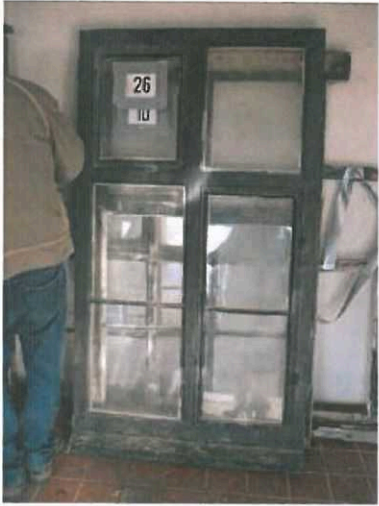
2.16	<p>WINDOW 26: Six paned timber framed window with central mullion, transom, one fixed fanlight, one metal opening fanlight, one low level fixed light, lower metal opening casements, single glazed, size 98" x 67".</p>

<p>REPAIRS: Carefully strip the paint from the window frame and remove the glass where necessary in order to facilitate the repairs. Carry out a squinted half lap splice repair to the left hand jamb forming a new tenon.</p> <p>Overhaul the opening casement and window furniture to ensure they are operating as intended and prepare ready for redecoration.</p>	ITEM

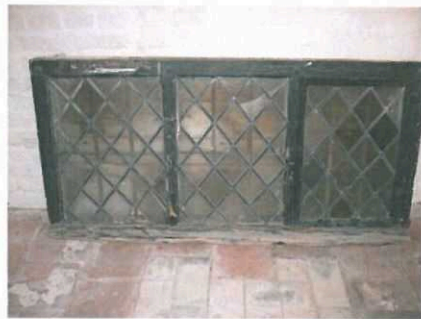
2.19	<p>BASEMENT: Oak framed window and cill, with three leaded lights, two fixed and one metal opening casement, C17th leaded glass, size 52" x 25.5".</p>

<p>REPAIRS: Carefully remove the leaded lights and send to Devlin Plumber Stained Glass Ltd to be refurbished. Remove the paintwork from the window and casement.</p> <p>Allow to replace the defective Oak cill carrying out squinted half lap splice repairs to the lower sections of the jambs and mullions, where necessary to facilitate the replacement of the cill. Allow to carry out an isolated splice repair to the head of the window. Allow to prepare the window and metal casement including the window furniture for redecoration.</p>	ITEM

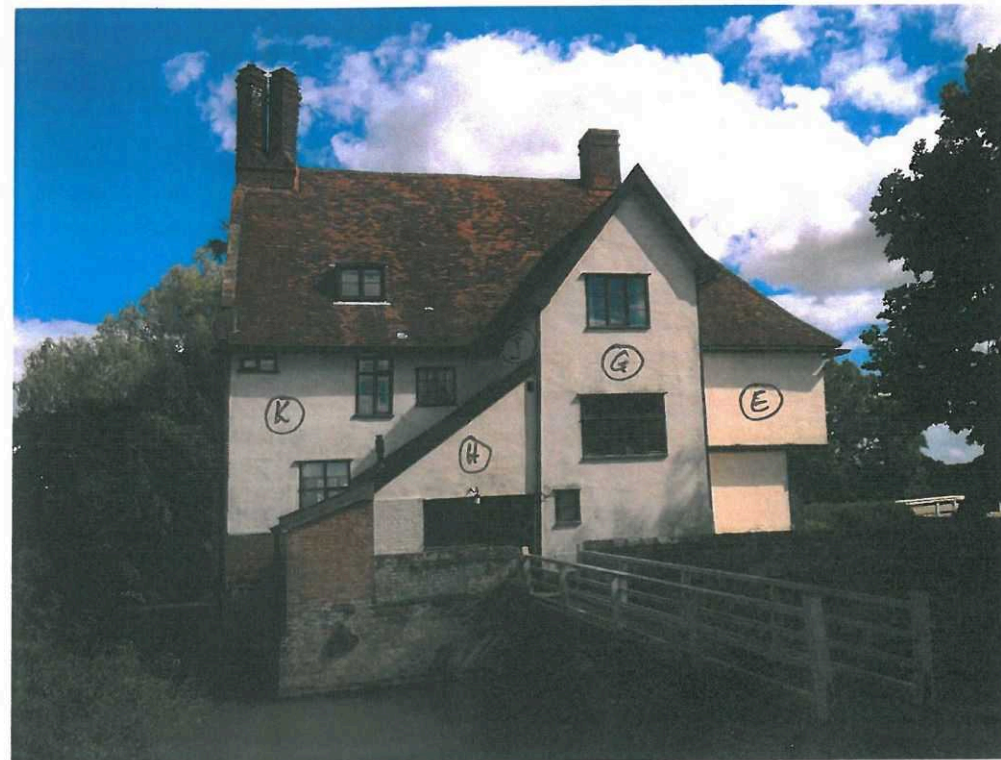
These elevations (K) and (J)
Are thought to be lime render.
Subject to testing, make good
only after window replacements

Remove cement paints from
brickwork at base of elevation (H)

Elevations (E), (G) and (H) to be
rendered as (A) + (E). Break
Ashlar lining pattern at corner between
(E) and (F)
