HERITAGE REPAIRS REPORT

Project: Letheringham Lodge, Nr Wickham Market, Suffolk, IP13 0NA
Clients: Mr M & Mrs P Bickerton

LEATHERINGHAM LODGE – HERITAGE REPAIR REPORT

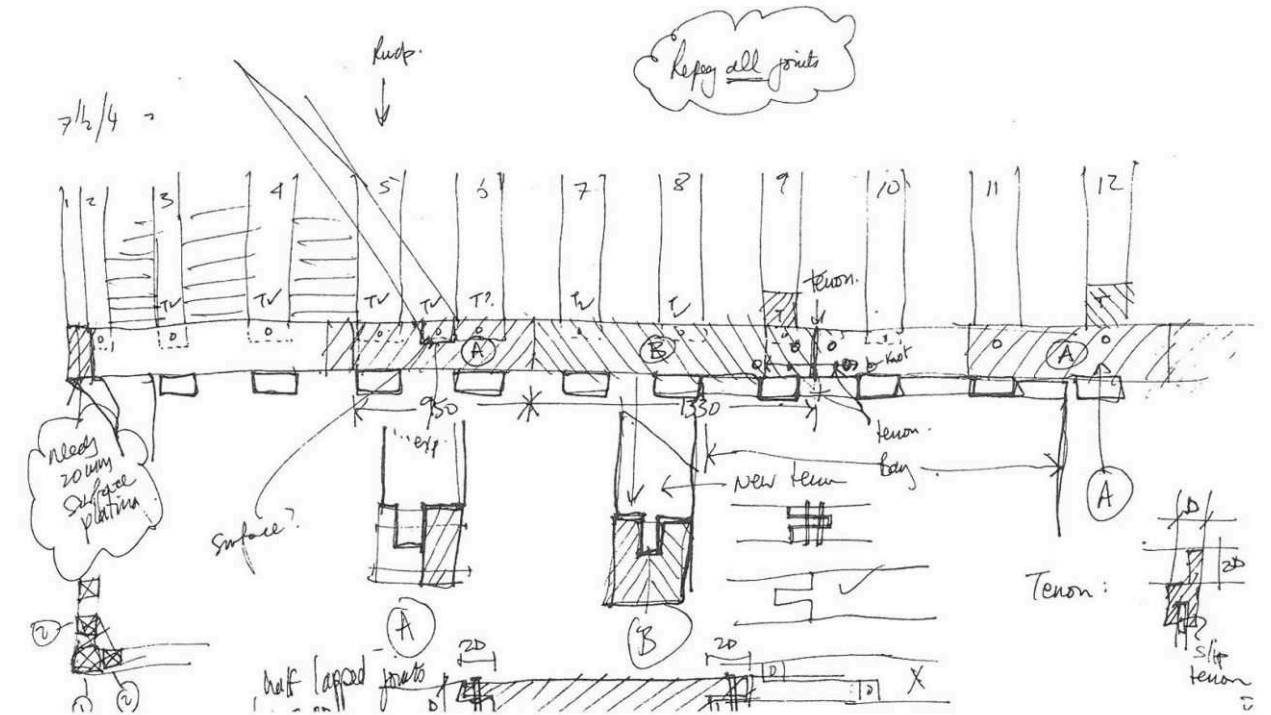
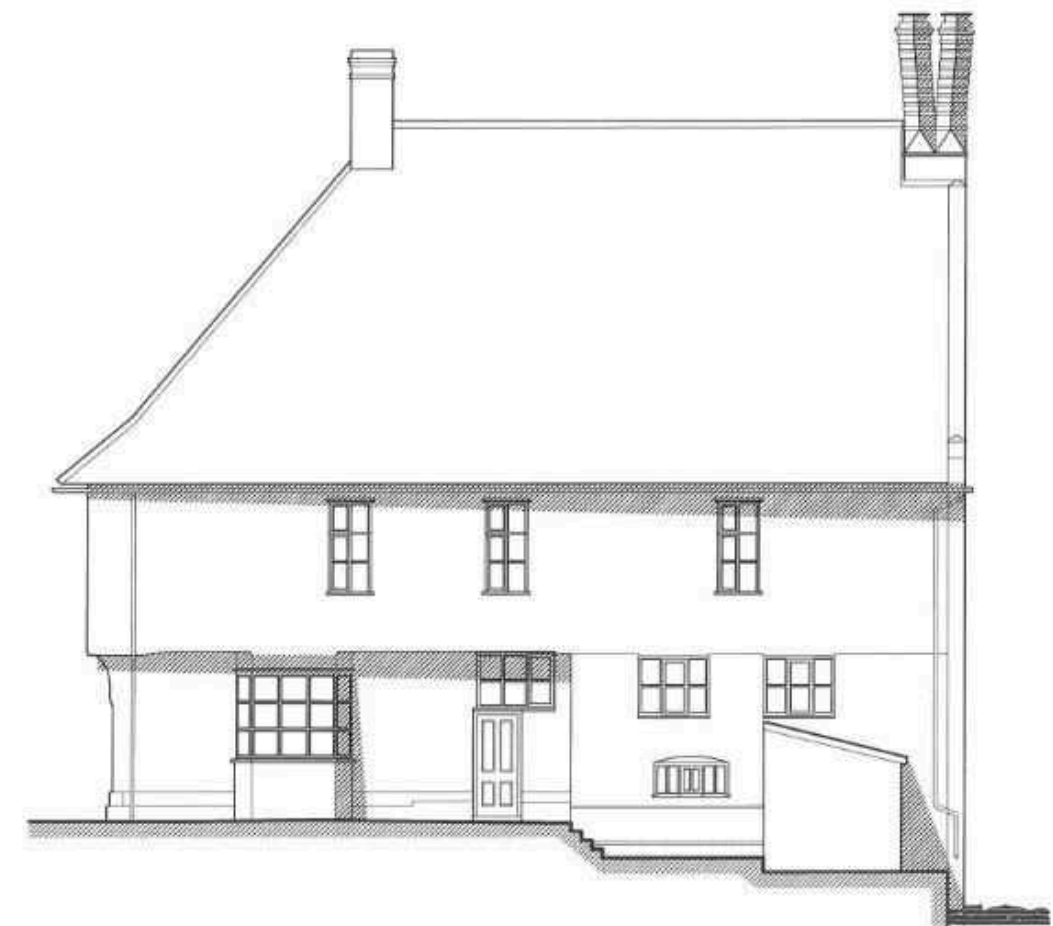
8. There was no evidence of windbracing to the northern end of the first floor structure up to stud 21.
9. Narrow gap and a week half lap joint noted to jetty plate between studs 21 and 22. Plate continues north of stud 22 to similar dimensions, as far as stud 32 (1578, 1580). Render above jetty plate noted to be lime based and thus not removed. Jetty under built between 21 and 37 with a brick structure, part rendered and part covered in a Weathershield type modern masonry paint.

10. Stud 33 appears to be the end of an extension, with the plate half lapped onto it and pegged (1560), suggesting that the extension was added at the same time as the under built brickwork, which takes the load from the first floor structure above. Had this been a separate structure, the plate would have supported the post, rather than been secured to its face only.

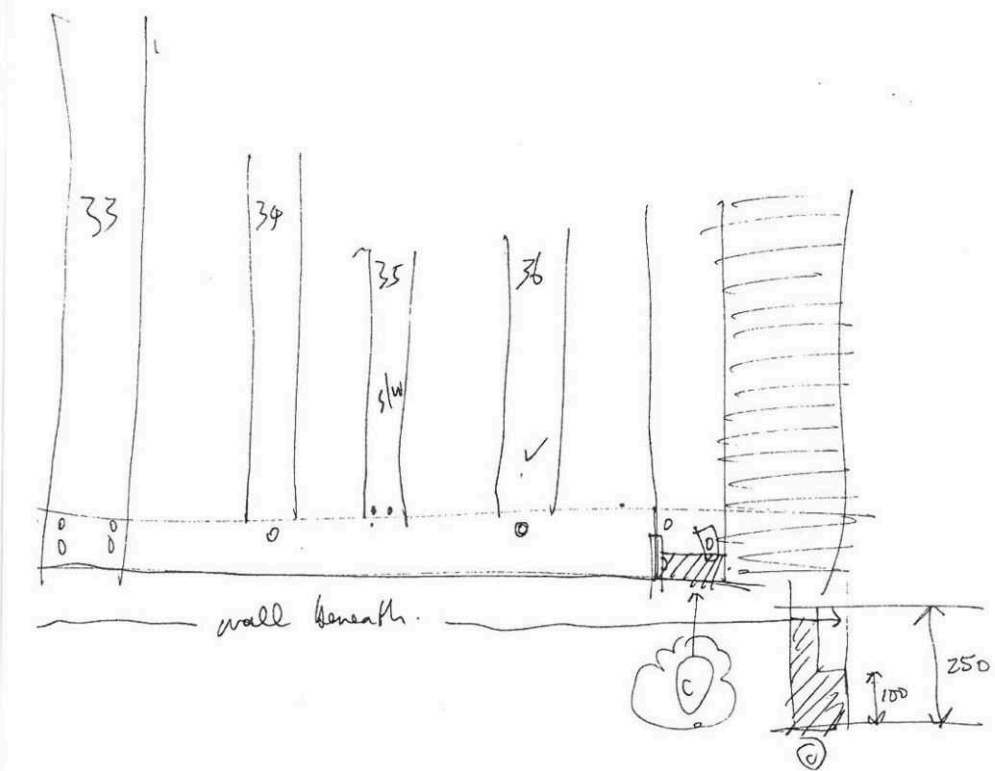
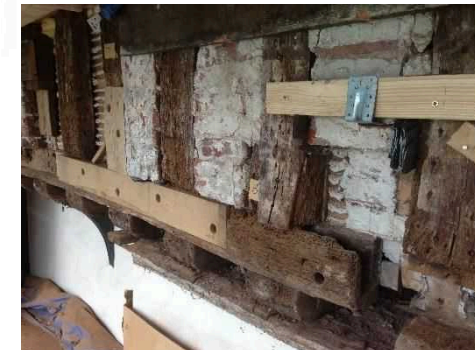
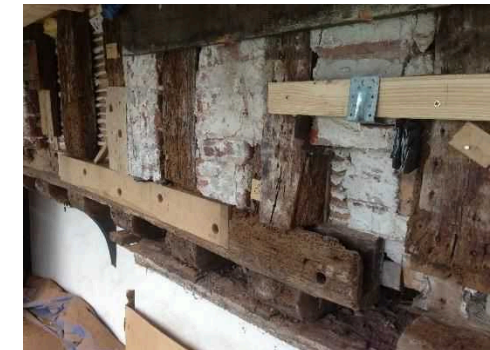
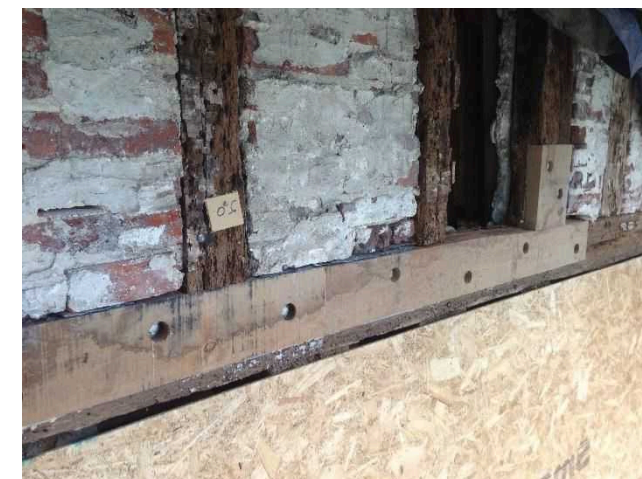
1. Sill beam under dragon heavily decayed and post piece repaired in new oak, together with section of plate in south wall adjacent to it (2264).
2. Sill beam to west elevation (w20 to D4 and slightly beyond), heavily eroded due to wet rot and face boarded back to mortise, coach screwed onto plate and re pegged in two sections to replicate original joint (1838,1764). Short feet with false tenons applied to studs 9, 12, 14, 15, 18, 19 and 32 (1836, 1841, 1776).
3. Face repair undertaken to top of stud 21 to support upper dragon post (1829).
4. Upper plate face applied timber above studs 1, 2, 3.

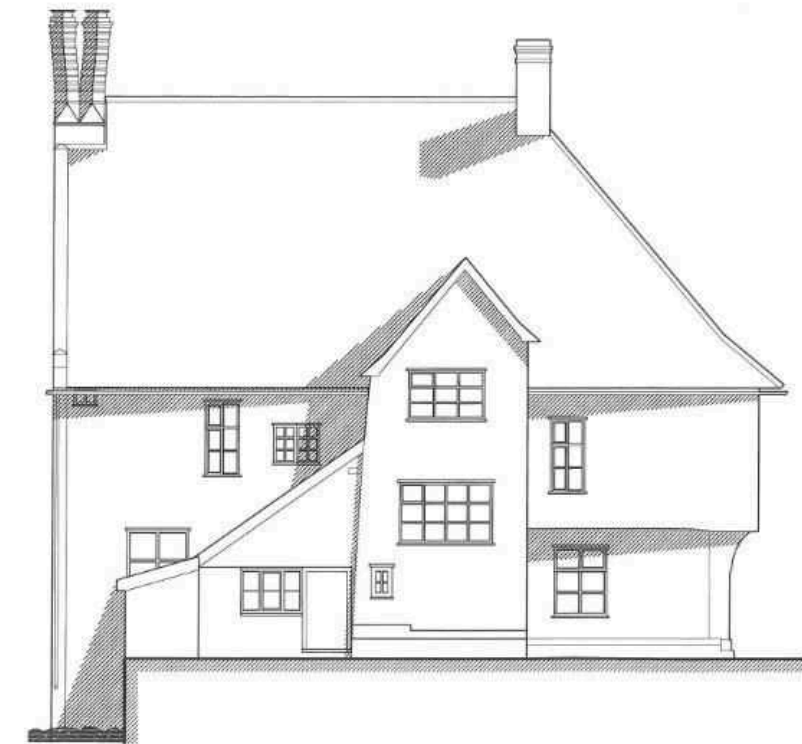
1. Jetty plate south of staircase affected by wet rot, affecting plate under studs 1 to 8. Plated to mortise.
2. Short section of jetty plate scarfed under stud 12.

3. No defects found or work undertaken to south elevation of staircase enclosure.
4. Western elevation to staircase found to have seriously defective sole plate, replaced entire length.

5. Softwood packing around window w8 removed and replaced.
6. Softwood plate under window 13 affected by wet rot decay, replaced in entirety (3876).
7. Softwood plate over window w 13 defective at both ends due to wet rot, and replaced in entirety (3878).

8. No significant defects found or repairs undertaken to north elevation of staircase enclosure.
9. Upper haunch to post found to be seriously affected by timber decay (death watch beetle and wet rot), such that discontinuous junction and load path between roof and jetty post. Complex repair undertaken using three sections of oak to rebuild top of post and end of dragon beam.
